Name: Tunga Inlet
Latitude: 55°58'32"
Longitude: 133°14'38" 29"
Geodetic Map No: Craig D-4
Location: El Capitan Passage, Tunga
Inlet, N head Salt Water Lagoon, creek and
lake system including tributaries

103-90-10090
Catalog No: 103-90-09
Former Stream No: FWS 25, ADF 159A
Work Area: Ketchikan
Watershed Length: 3.3 miles
Drainage Area: 3.6 mi
Water Supply Type: source is at a lake

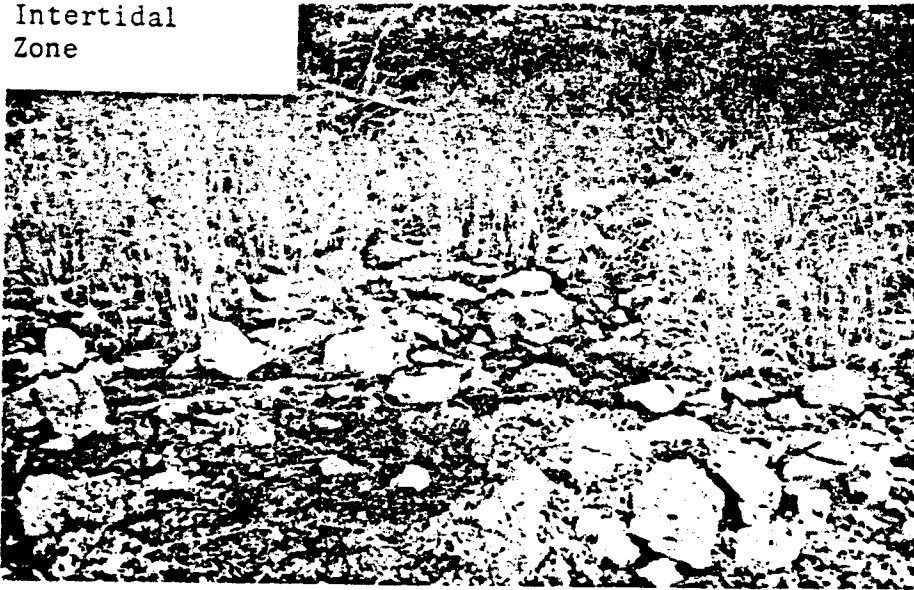
Intertidal
Zone

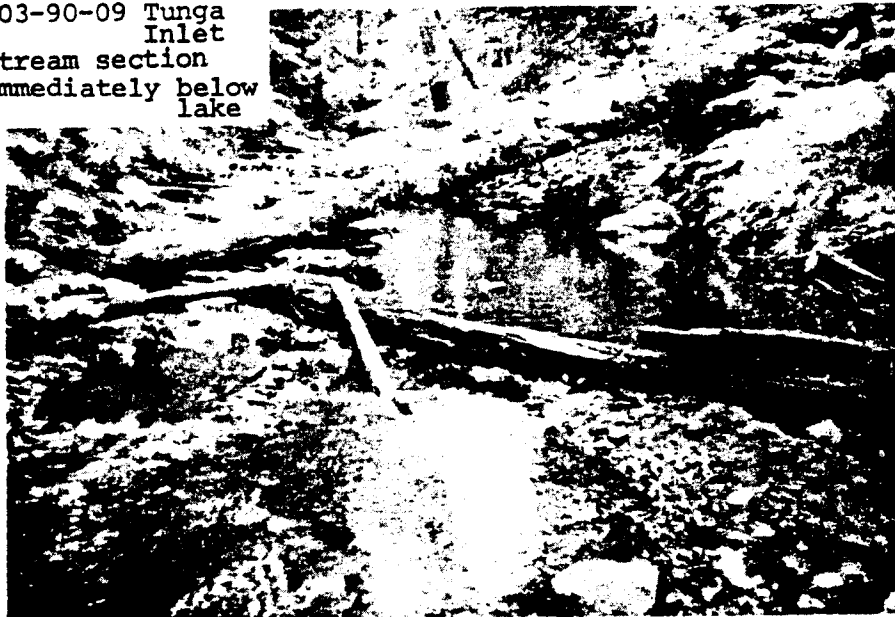
103-90-09 Tunga
Inlet
Stream section
immediately below
lake
